## **4.0 POST TCRA ACTIVITIES**

### **4.1 Demolition Site**

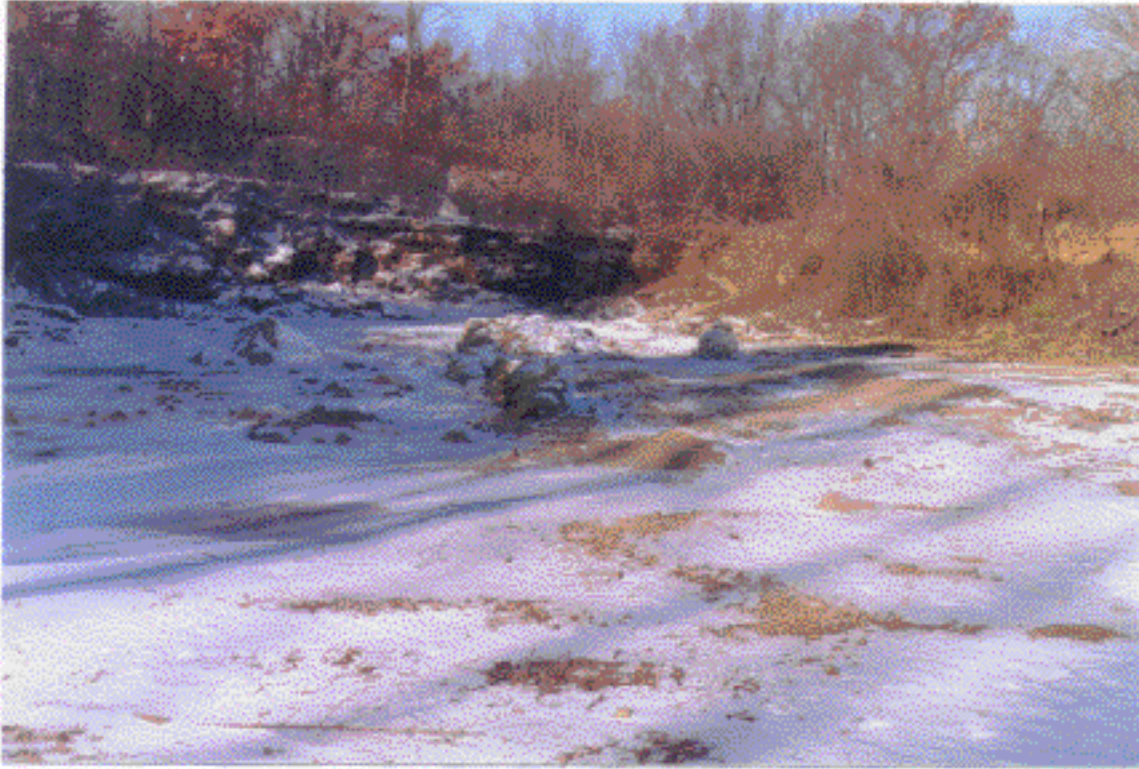
**Figure 4.1 Disposal Area Looking South-West**

Figure 4.1 and 4.2 depict the residue of the 12 disposal areas as they appeared on 14 November 1995. The small mounds to the left of the wall of sand bags in Figure 4.1 and to the right of the sandbags in Figure 4.2 are the remains of the small disposal pits which had originally been constructed of sand bags. After completion of disposal operations and in agreement with park personnel, intact sand bags were stacked in a row and damaged sand bags were dumped on the spot with the cloth portions being disposed of by UXB.
